Surface Flooding and Drainage Investigation and Options Appraisal Report 2021

Report produced in association with residents by
Mr M Inder
Clerk to Shouldham Parish Council

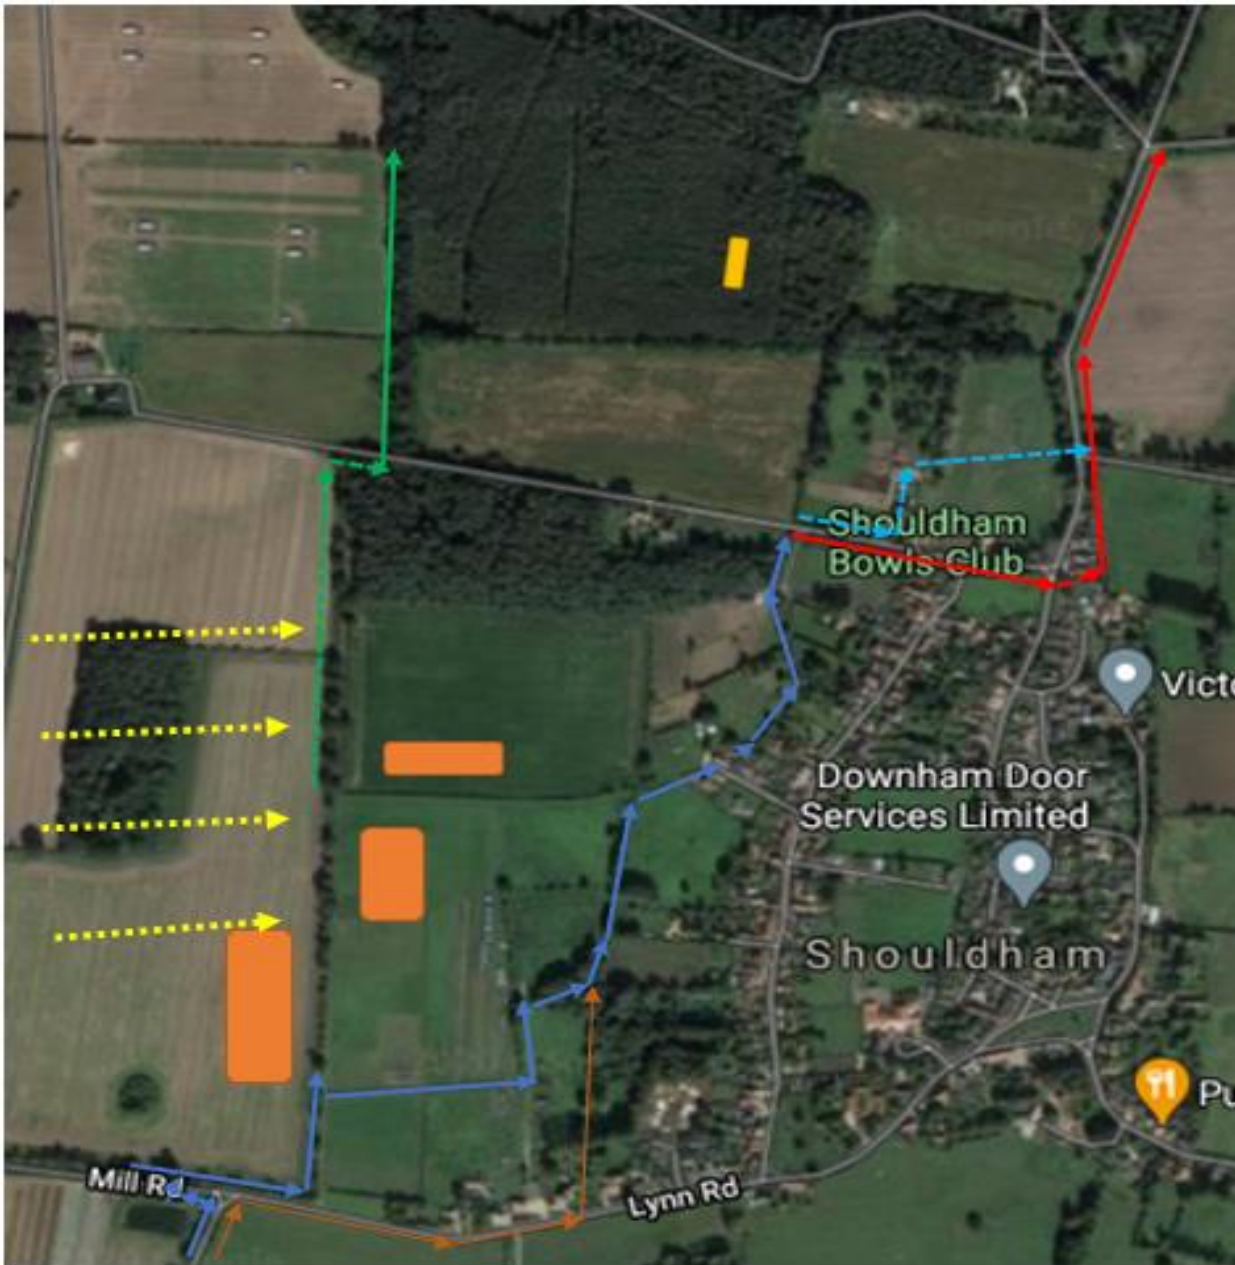
Diagram 1.

Drain from Shouldham Thorpe under the Mill Rd diverting surface water from Shouldham Thorpe.
-

Dyke and pipe drain on south side of Lynn Rd, runs north under the road near 30 Lynn Rd and joins the Mill Rd/FP3 drain.
-

Pig Farms – Pigs are known to tread down the surface creating impermeable ground and more surface run-off rather than the ground being a natural soakaway.
-

Run off with no ditches, washing silt (and currently pig effluent) from fields into drains lower down the fall.
-

Possible solution is a relief ditch/pipe from Fairstead Drove to existing dyke towards the Warren downstream of choke points.
-

Possible solution a new drain to divert higher field run off directly to Fairstead Drove and into existing drain that avoids the lower reaches of the blue system to the Fairstead Drove drain.

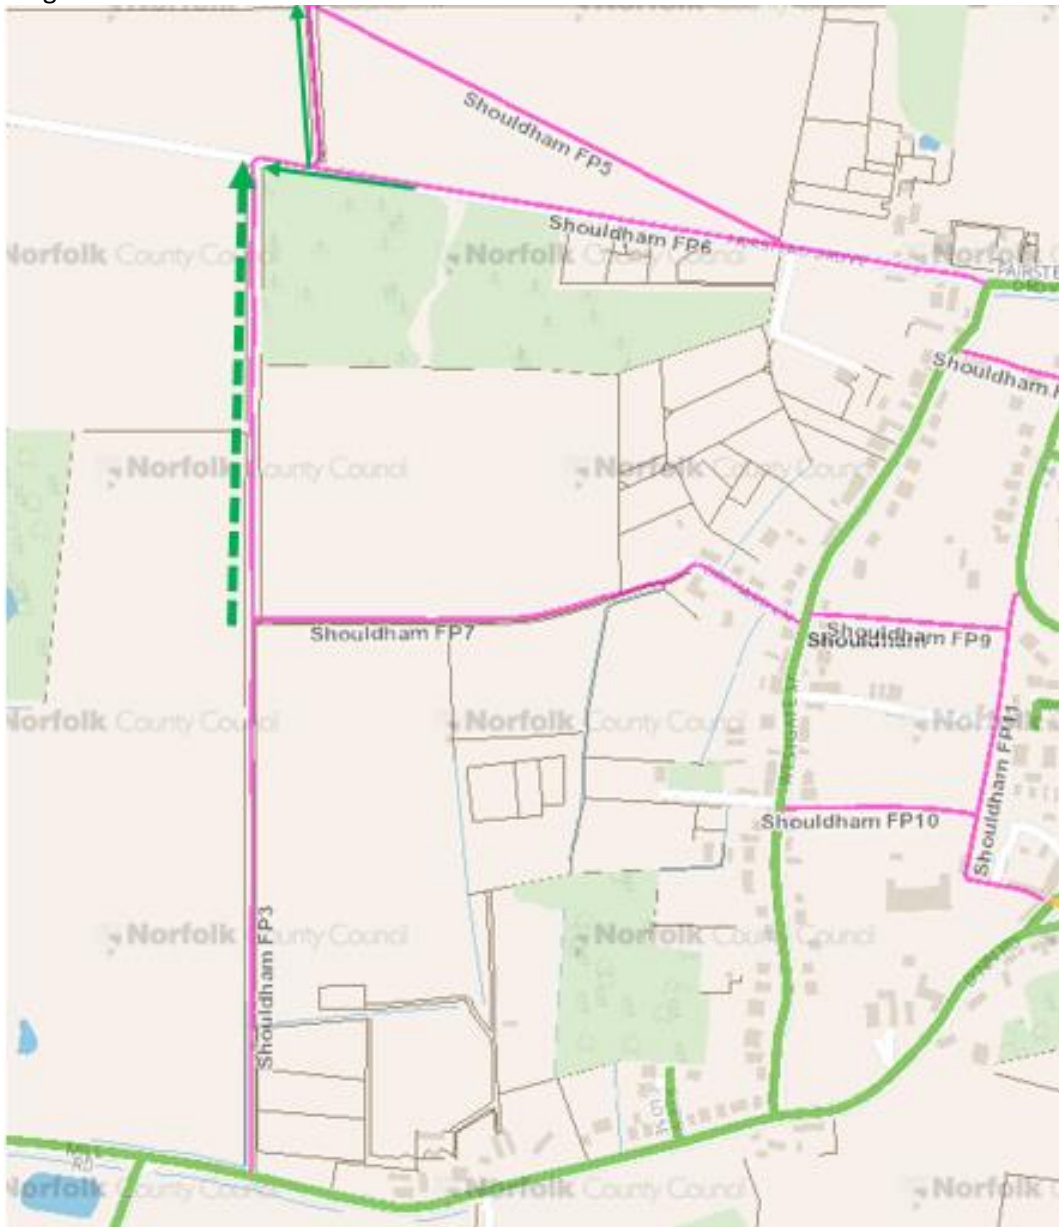
Diagram 2.

On Sunday 24th Jan a group of Parish Cllrs and the Clerk surveyed the route from the Bowls Club along Fairstead Drove (Shouldham FP6) along to the intersection of FP3, along the entirety of FP3, up to Shouldham Thorpe junction and back down Lynn Road and Westgate Street.

The flooding on Fairstead Drove had subsided and the blocked pipe under the driveway was more evident. There are no drains at the side of the FP road until about halfway along, a very slow running and not very deep drain runs on the northside to the junction of FP3 and has a pipe under the drove to connect with a ditch running freely and with at a not very full that heads north towards the Warren alongside FP5. Turning uphill along FP3 (Mill Drove) the FP was very muddy with deep tractor tyre tracks acting as drains. The footpath was impassable in places and the group had to walk at the extremities. It was evident that the area would benefit from a drain dug on the west of the FP to clear surface run off from the fields above to the west down to the ditch at Fairstead Drove.

The FP remained extremely waterlogged with some surface flowing across and down the fields toward the rear of Orchard Lane and Westgate Street (nos 83-63), even though it had not rained for 36 hours and there was a dusting of snow with the temperature still around 1 deg C.

The flooding at Mill Road junction with Shouldham Thorpe Rd was still significant although not as bad as the previous survey, this despite the break in rainfall was considered to be a surprising flow.

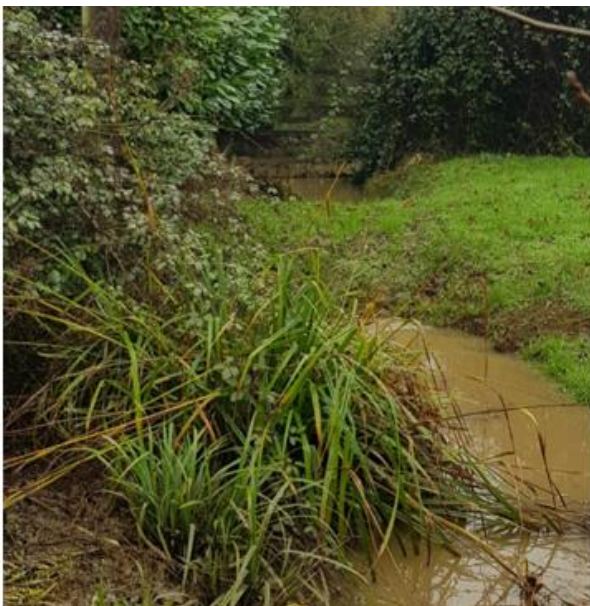
Photo 1.

Photo taken from NW corner of 67 Westgate Street looking at the piped grass bank at the bottom of the garden at 79 Westgate St.

Water level before the pipe looked higher than downstream (albeit the photo does not make that clear). Further investigation and resident reports that the levels when viewed more closely on a regular basis hasn't been noted as having a differential.

- Inspection and rodding of the pipe at rear of 79 Westgate Street and measurement of the pipe proved this not to be an area of concern, although the owner of 79 Westgate Street stressed the importance of all parties clearing vegetation from the ditch on a regular basis. Neighbour dialogue on an agreed mutual beneficial approach is ongoing.

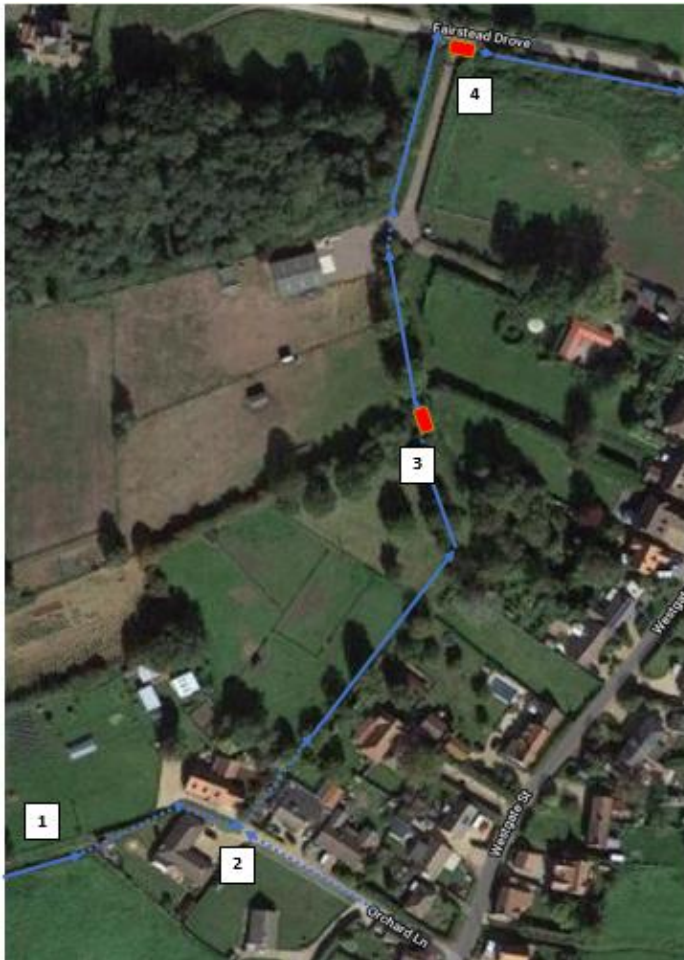
Diagram 3.

- 1 Sleeper silt trap before pipe inlet
- 2 Manhole cover at 3 way junction – approx. 50% silted pipes
- 3 Open ditch runs through a 400mm pipe under grass bridge at rear of 79 Westgate St. May cause a slight choke effect under severe conditions.
- 4 Large bore pipe under roadway, $\frac{3}{4}$ silted, requires clearing and silt trap step dug before inlet.

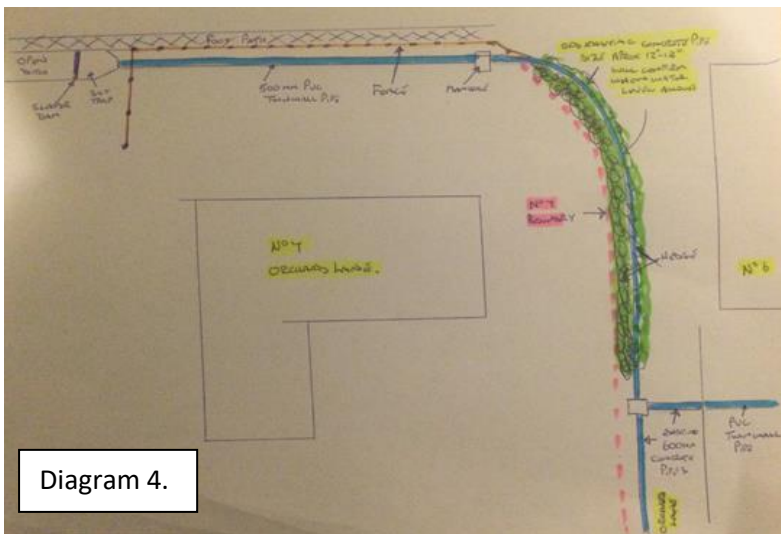
Diagram 4.

From the open ditch to the manhole within boundaries of no7 there is a 500 mm pvc twin wall pipe, from the manhole there is an existing concrete pipe, believed to be smaller than 500mm, probably an old 18inch pipe (TBC when water level drops) that runs either under the hedge or just No6's side of the hedge. Not sure who installed this old pipe? Possibly Council, but it was before 1989 when Mr Chapman purchased No7 building plot.

4 Feb 21 - The 500mm pvc twin wall pipe running through No7 has a small amount of silt in it and a bit of a build-up of silt at ditch end, but this will be cleared when water level drops. Mr Chapman clears silt at the open ditch end where he formed a sleeper dam/sump several times a year and also rods out the 500mm pipe run.

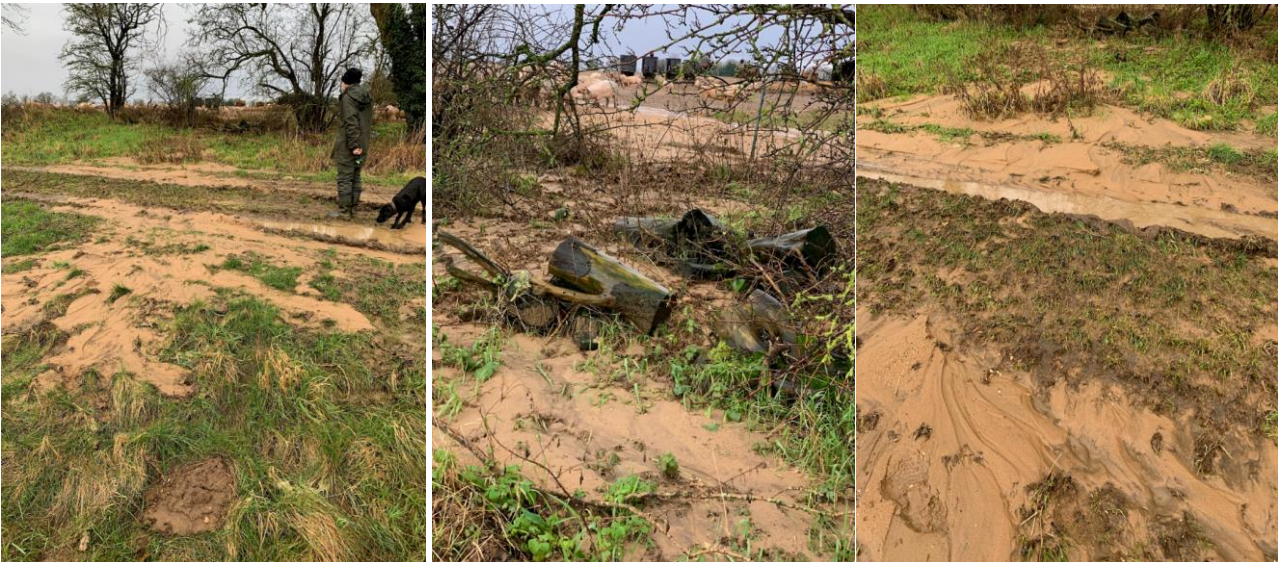
West of Mill Drove – tracking down to the lower field pictured above.

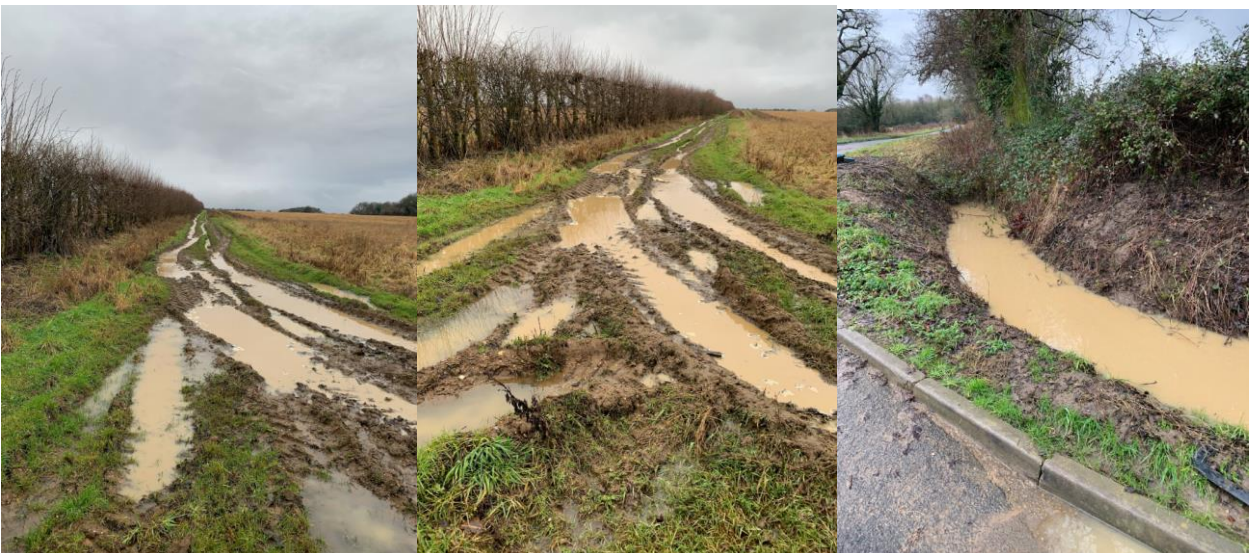
Shouldham Thorpe field above Mill Road feeding drain and down to Shouldham.

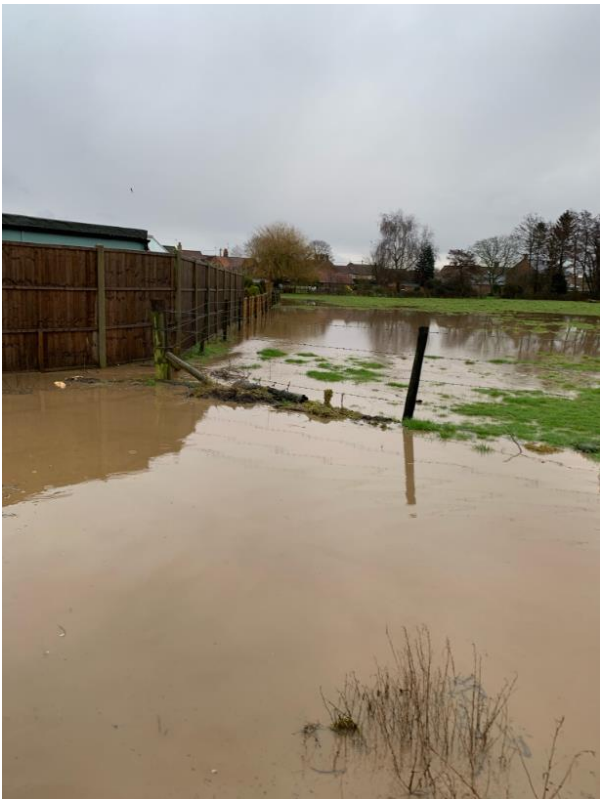
Bottom of lower field with pigs in behind No6 & 7

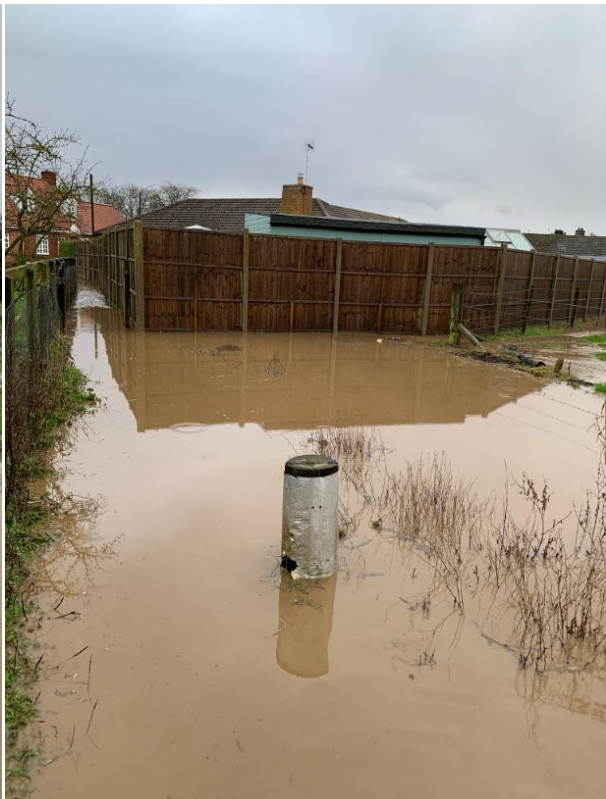
Rear of no 7 Ditch runs to pipe at 2nd panel. Footpath left of bollard.

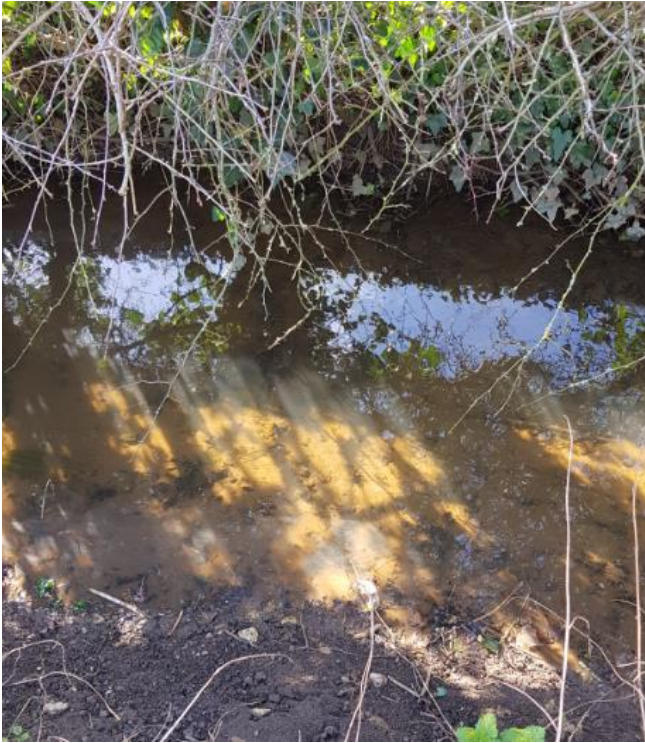
Fairstead Drove drain opposite Playing field. 24 Feb 21
Heavily silted and water depth approx. 5 inches.

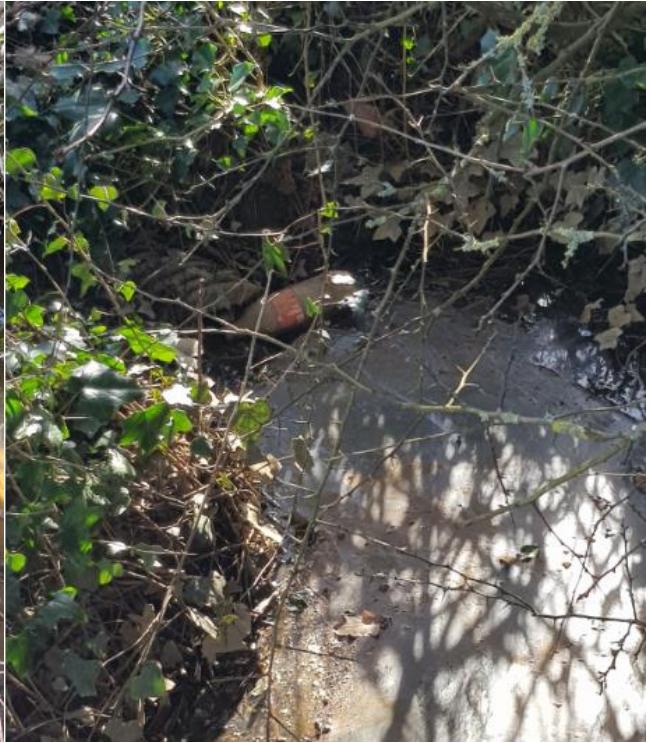
Pipe entry circa 7/8ths silted at inlet.

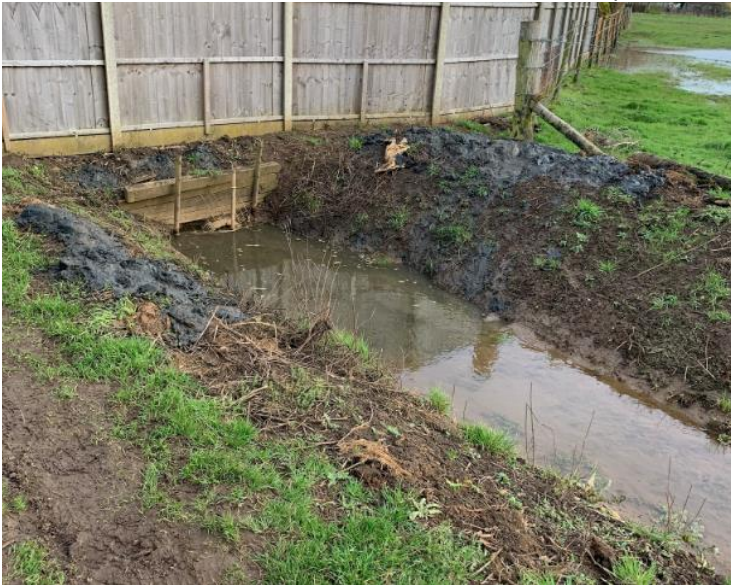
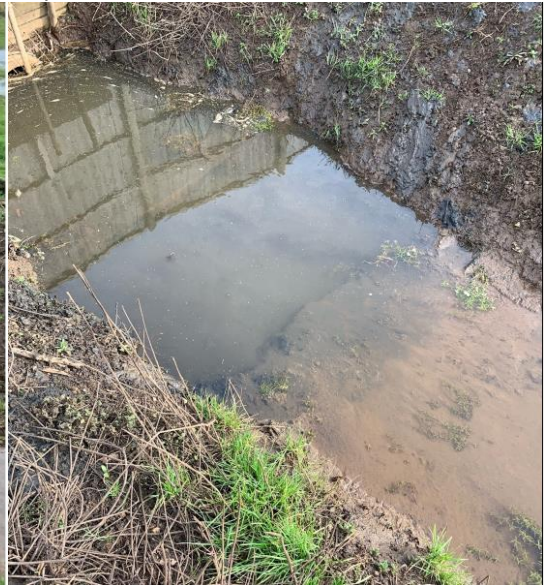
Photos rear of no 7 Orchard Lane 23 Feb – Silt to top of dam sleeper.

23 Feb 21	Email from Mr Chapman with photos of silt up to top of silt trap in ditch to rear of Orchard Lane. Request for mechanical assistance to dig out the silt to restore resilience of ditch and prevent further silt overflowing.	23 Feb – Email to Mr Esse requesting mechanical assistance to dig out the silt – 24 Feb – Response from Mr Esse: I will ask the manager of the pig enterprise to come and slub out the ditch from the corner to the sump. Hopefully they will be there in the next couple of weeks. 15 Jun – No work done, Email to Cllr GH to see if he can assist	Closed

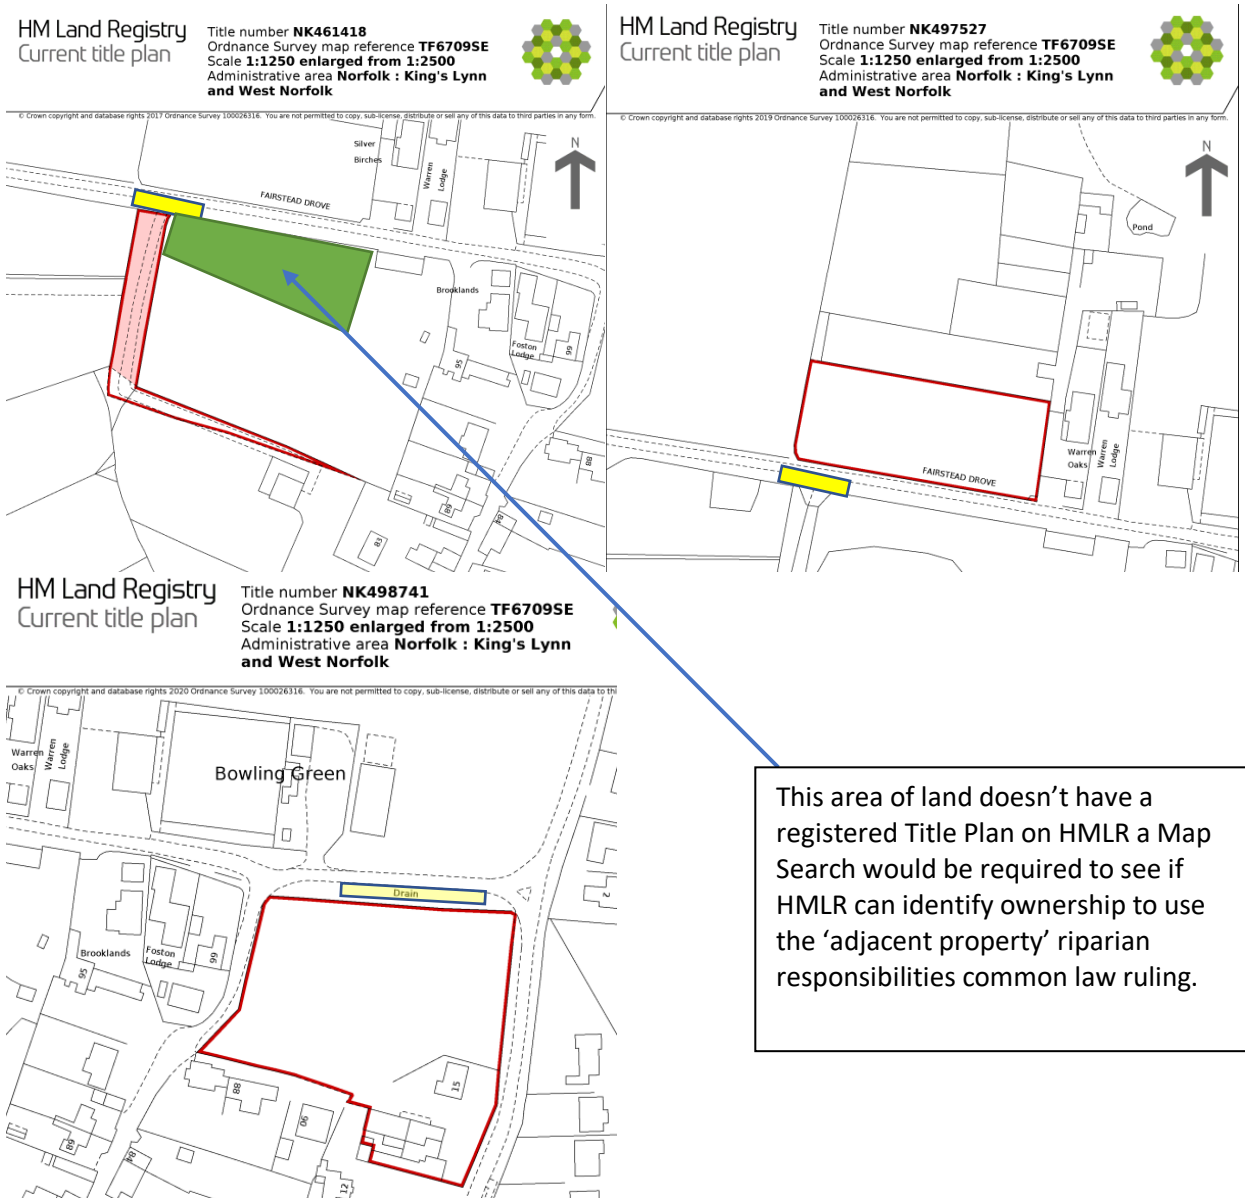
Land Registry Plans for Fairstead Drive.

Highlighted area where the partially blocked pipe goes under the driveway entrance to 81 Westgate Street is outside of the title plan boundary of both 81 Westgate Street and Warren Oak, Fairstead Drive. Application to HMLR to request search for registered owner to be submitted, this search is a low priority for HMLR processing during COVID-19 pandemic and estimate for a response is ‘months’. Furthermore, it is highly likely this request will not return a registered owner according to advice of Highways and Countryside Access Officer and resident’s local knowledge. So, advice on riparian responsibilities for that pipe and ditch alongside Fairstead Drive is required.
